SAINT FRANCIS DE SALES PHILADELPHIA, PA

INVESTIGATION PHASE
EMERGENCY STABILIZATION
PHASE I RENOVATION

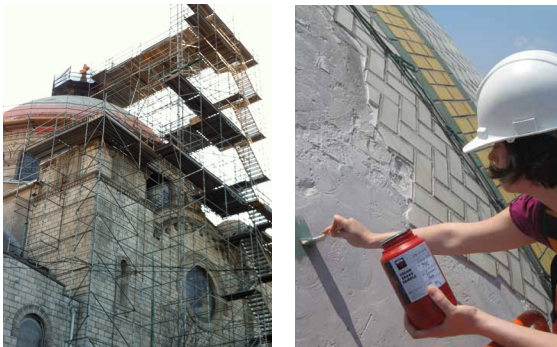
Scaffolding was needed to reach the dome

The Phase I Renovation focused on the repair and renovation of the roofing and rainwater conduction systems. Structural stabilization at the Lantern and Main Dome involved complex “needling” together of the mason walls. The Dome was painted using Guastavino’s original watercolors. The interconnecting roofs from the Lantern down to the square base at the Main Dome were replaced and new standing seam transept vaults were installed.

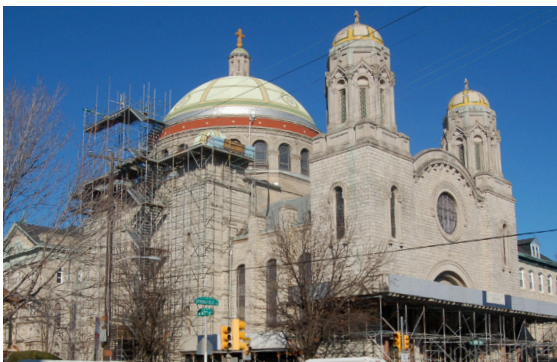
The new dome painted to match the original.

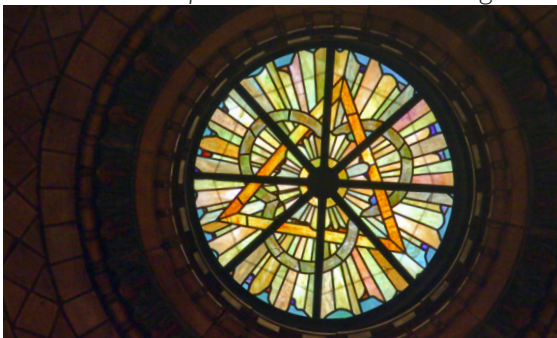
The restored stained glass laylight
